UNION LAKE DAM

PHASE I INSPECTION REPORT

NATIONAL DAM SAFETY PROGRAM

NJ 00448

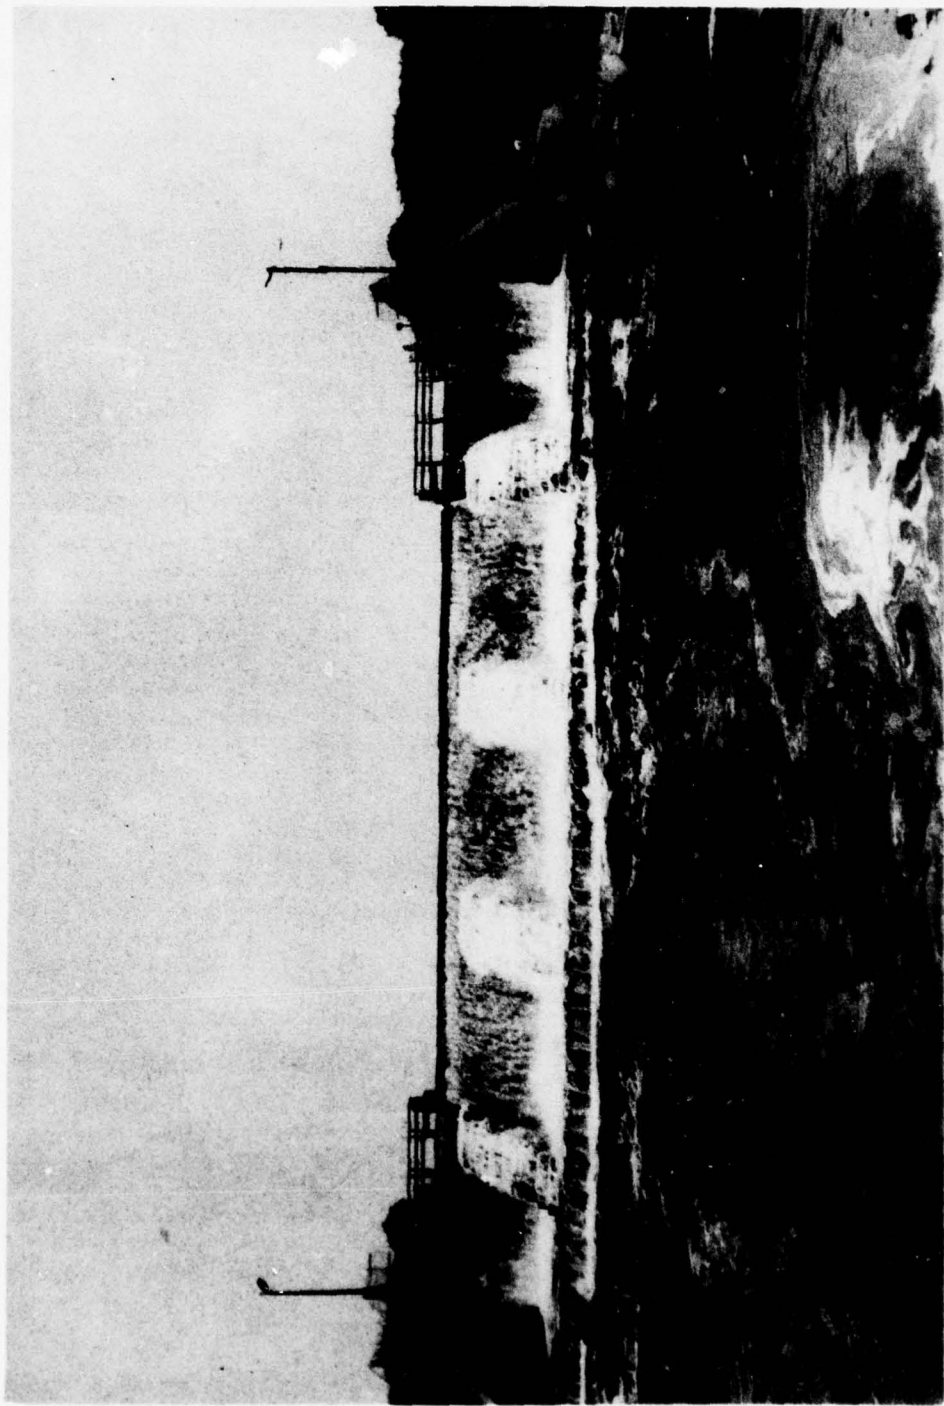
OVERVIEW OF UNION LAKE DAM

Union Lake Dam appears to be in a marginally adequate structural condition but substantial seepage was observed along the downstream embankment. The dam is over 100 years old and has withstood the test of time but sufficient engineering data was not available regarding the foundations, method of construction or zoning of embankment to allow a full assessment of its term-long adequacy. Further engineering studies in the near future are recommended without reservation. A collapse could cause irreparable structural damage to the dam and significantly endanger downstream residential areas which are quite heavily populated. Recommended remedial actions to be undertaken in the

near future consist of 1) refill the stilling basin with riprap, 2) place additional riprap on the upstream face, 3) channelize and monitor the seepage at the downstream toe, and 4) repair the penstock gate at the downstream powerhouse.
